Developing a Robust Municipal Stormwater BMP Maintenance Program

**Kevin Middlebrooks, Gwinnett County
Department of Water Resources**

Billur Kazaz, Ph.D., Geosyntec

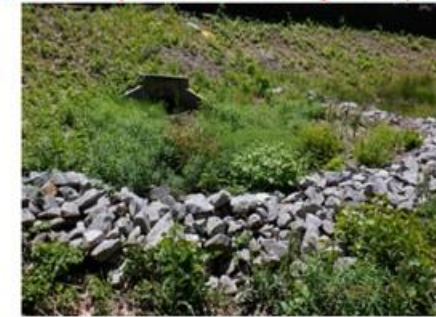
Remove sediment build-up at inlet headwall forebay.
Clean/turn rip rap at inlet headwall forebay.

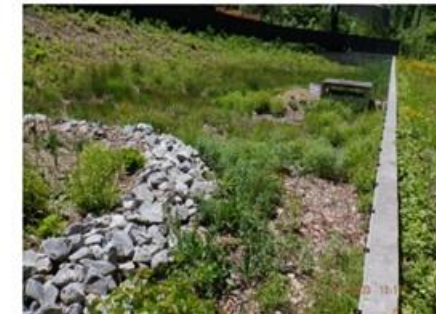
Remove sediment build-up throughout pond to ensure water flow is directed towards OCS.

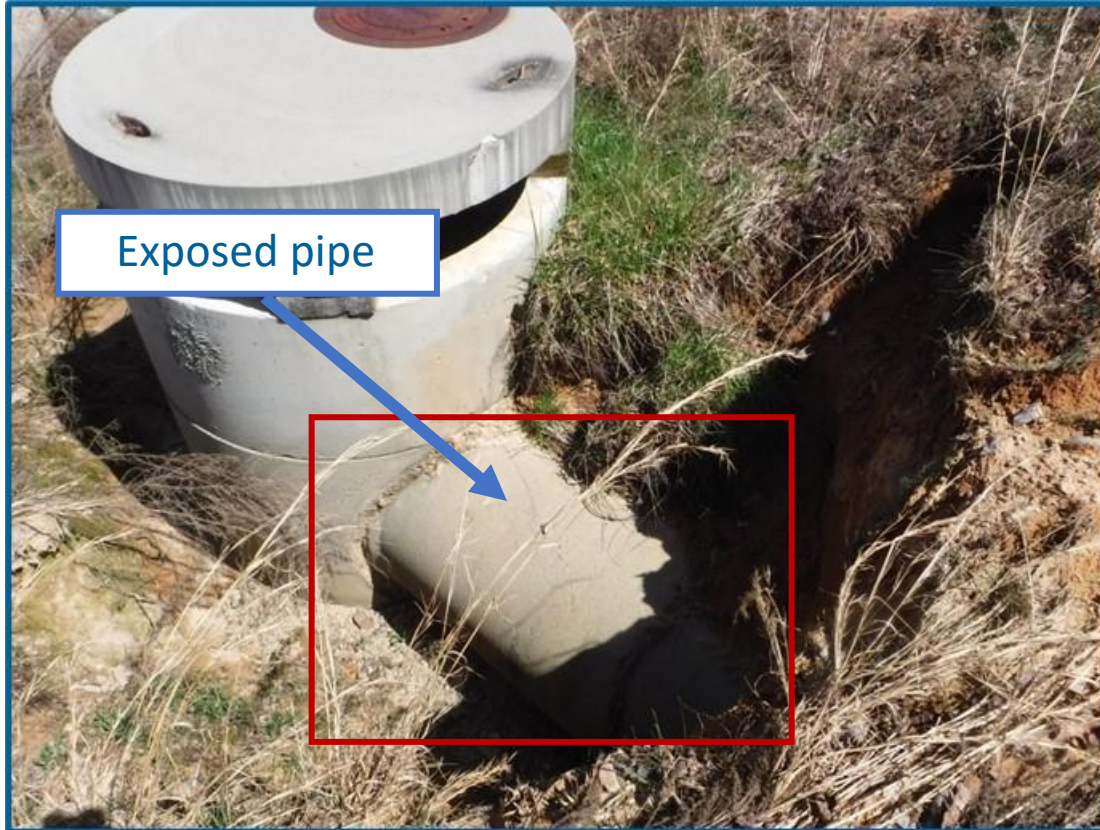
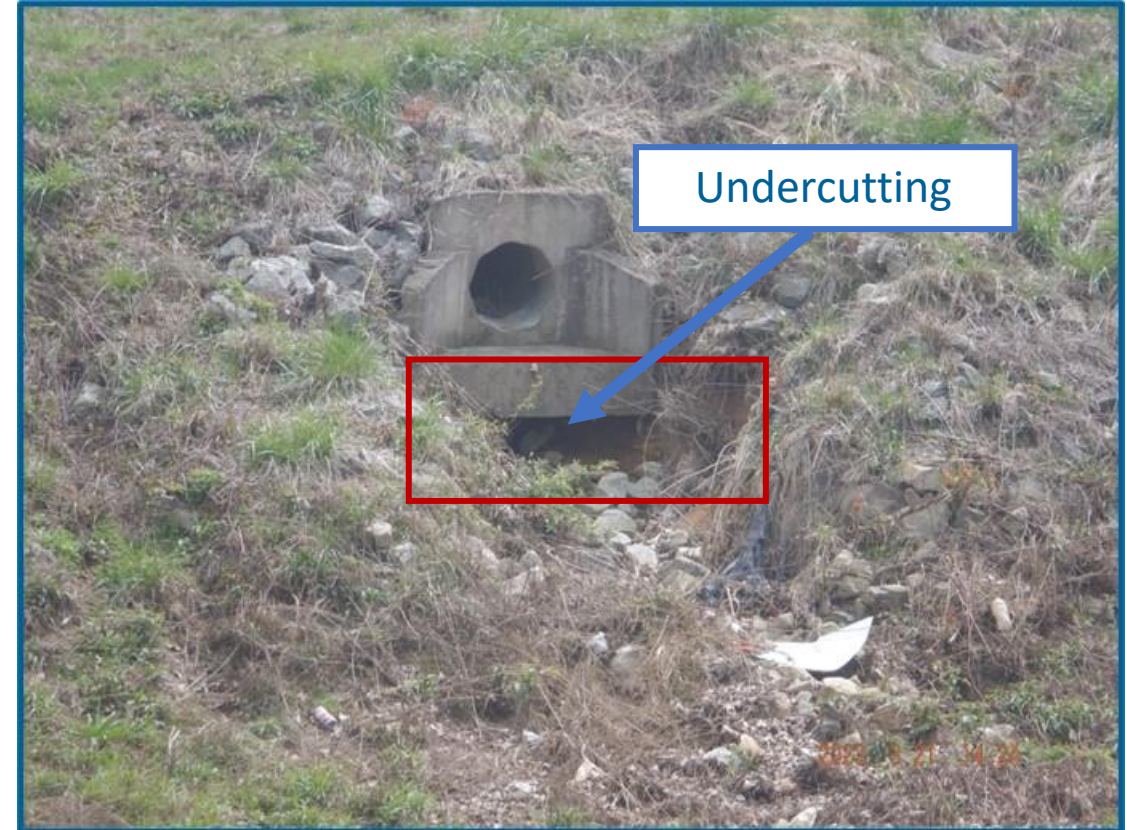
Typical BMP Deficiencies - Erosion

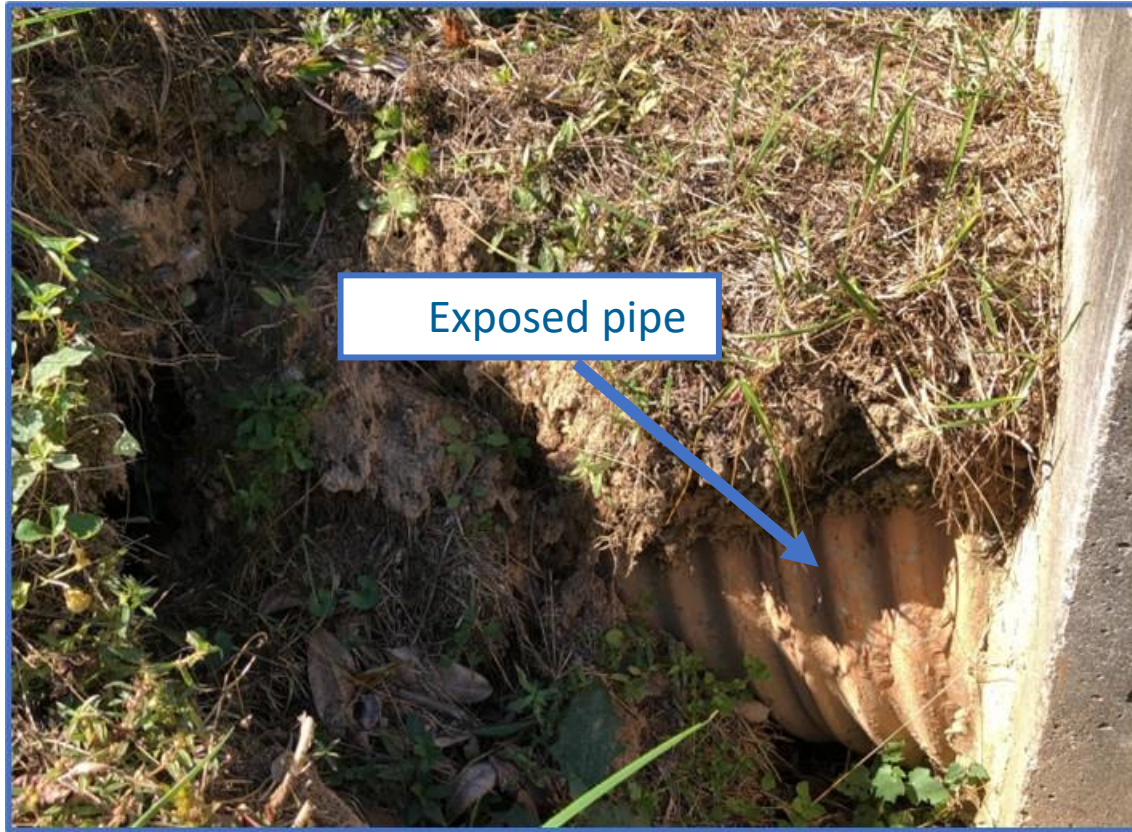
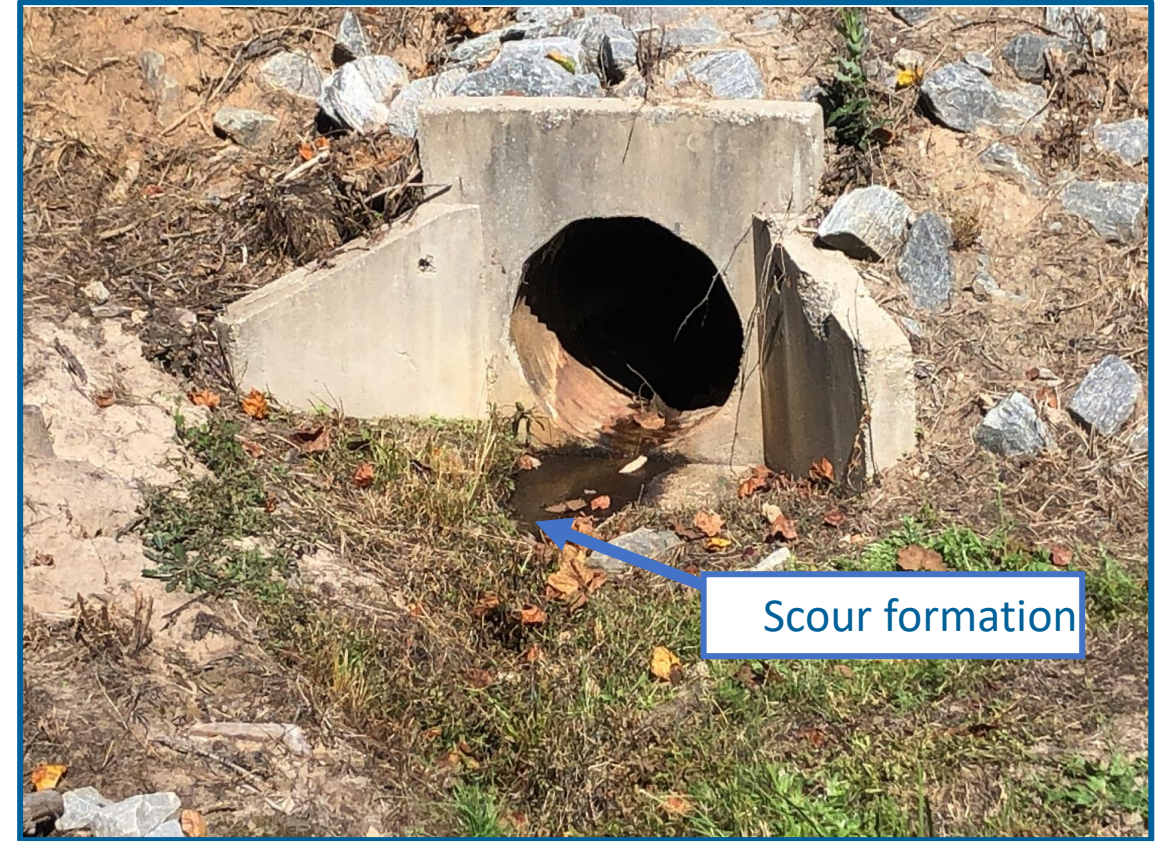
Typical BMP Deficiencies - Erosion

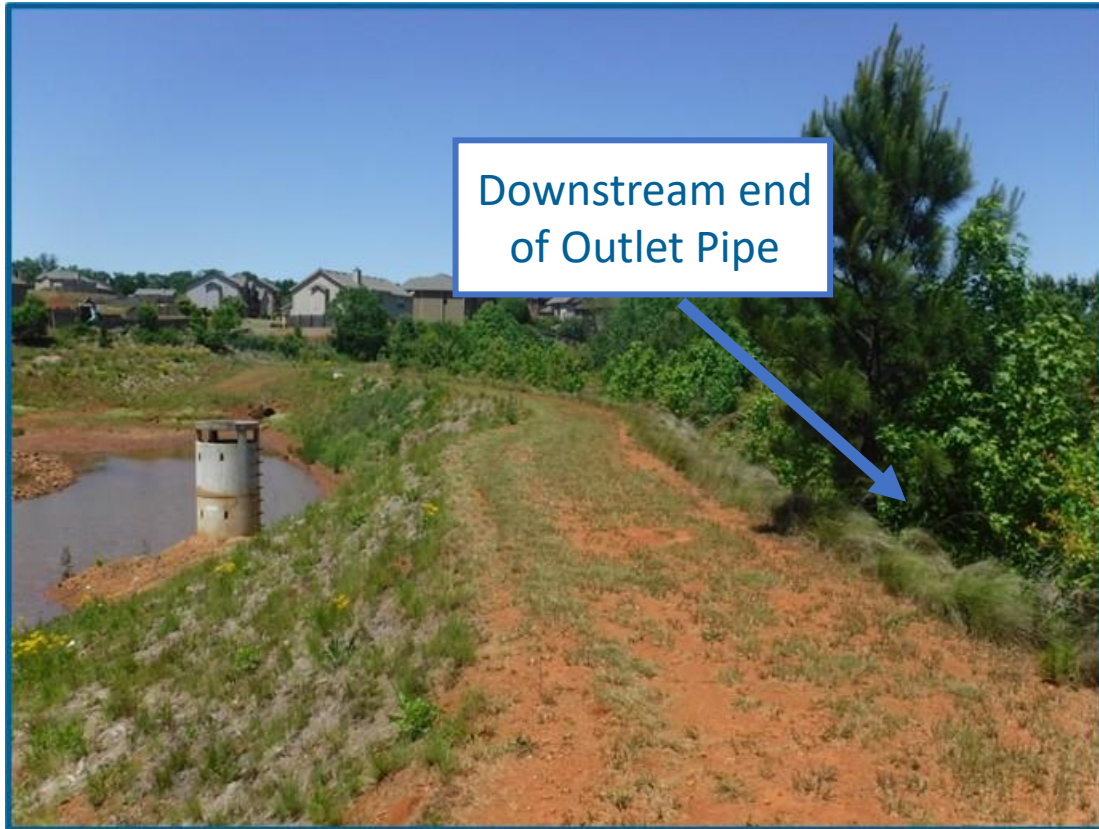
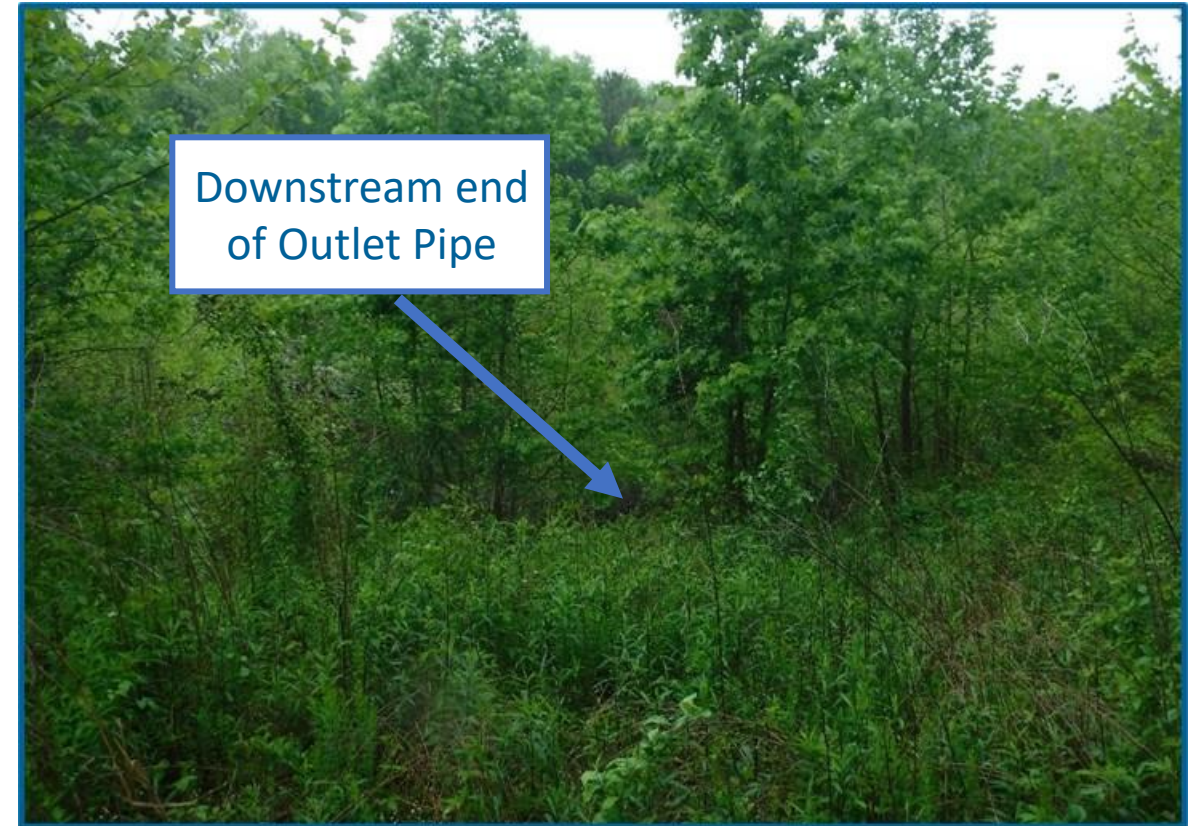
Typical BMP Deficiencies - Vegetation

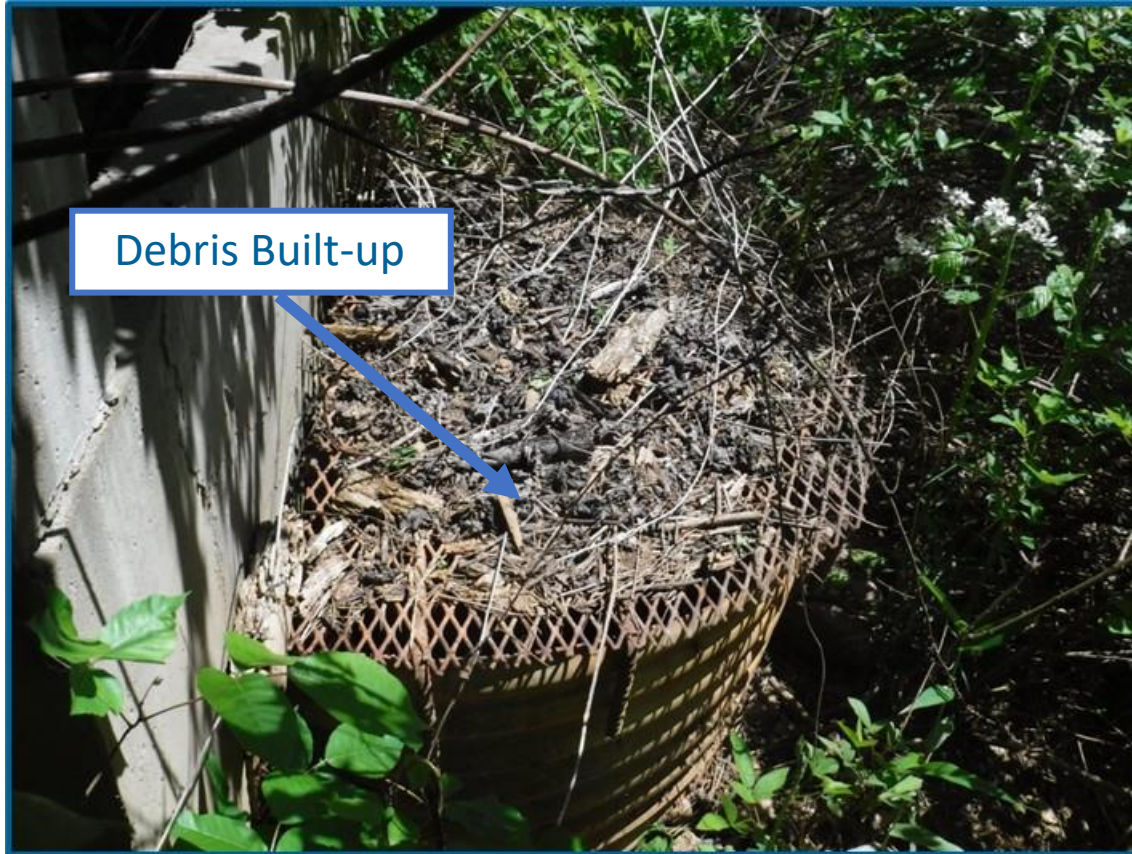
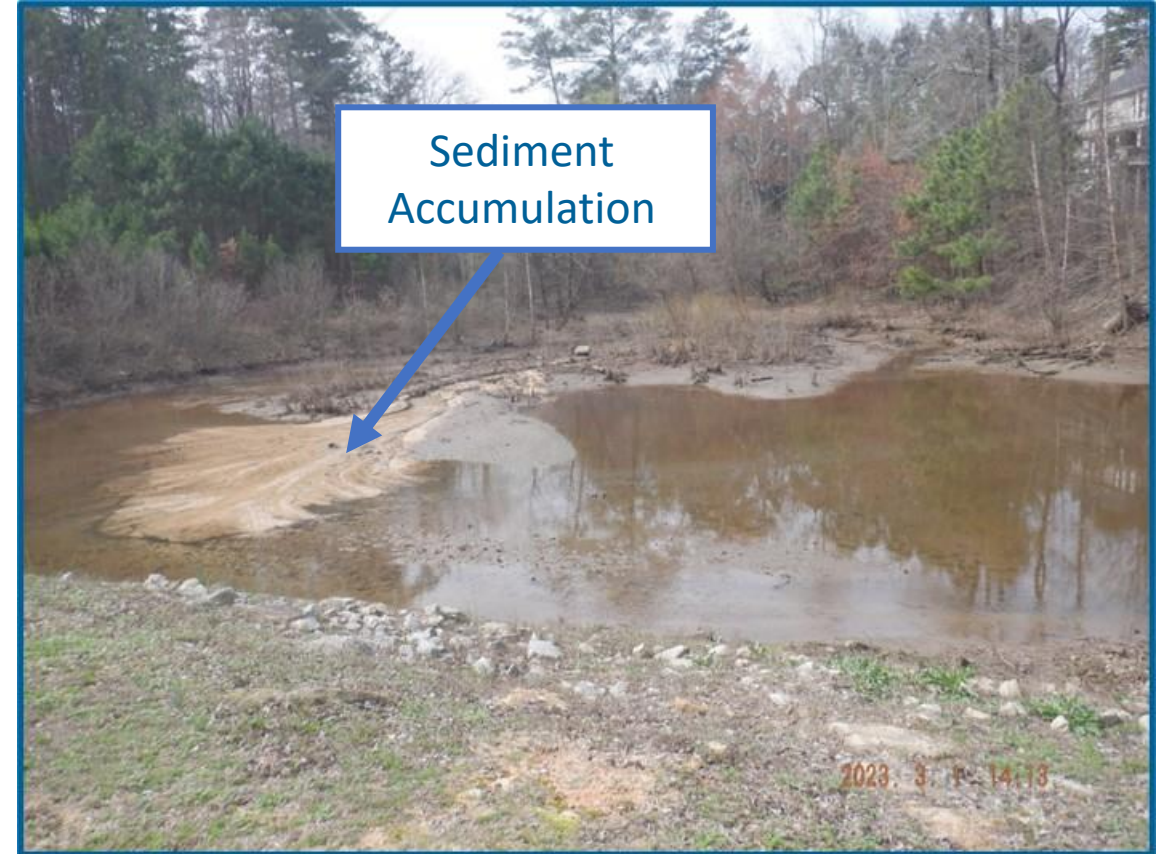
Typical BMP Deficiencies – Sediment & Debris

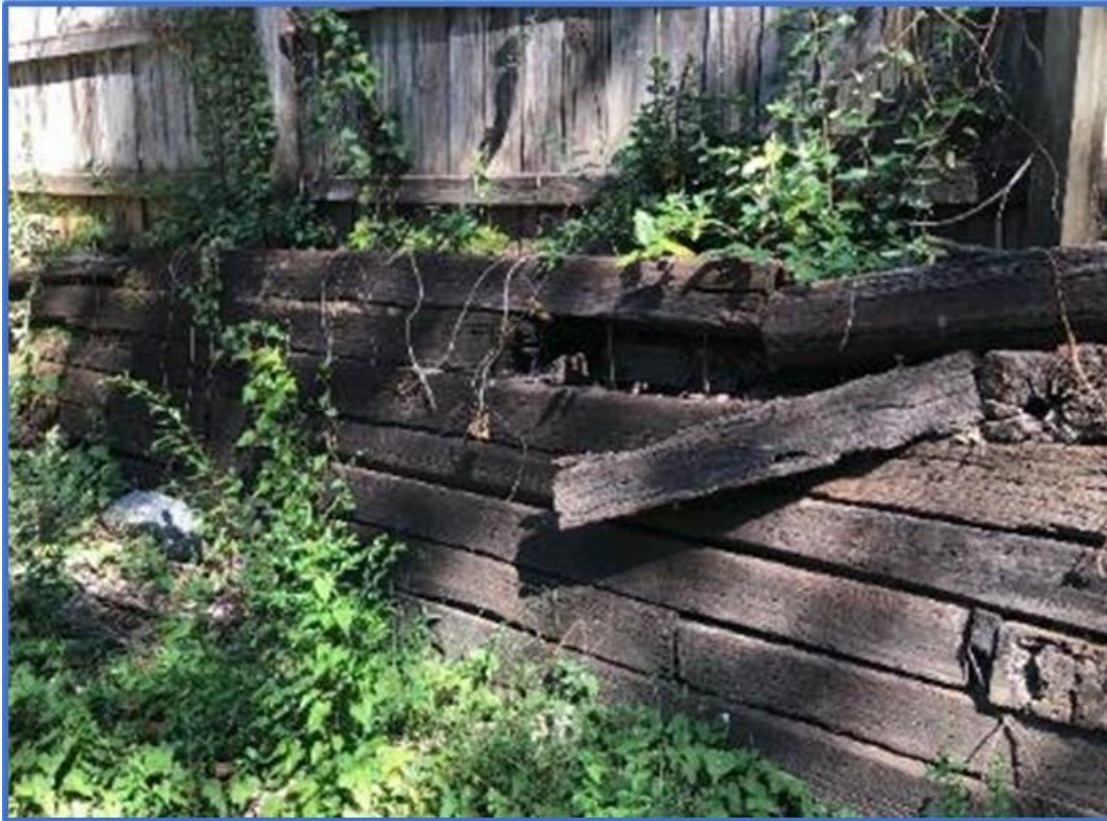
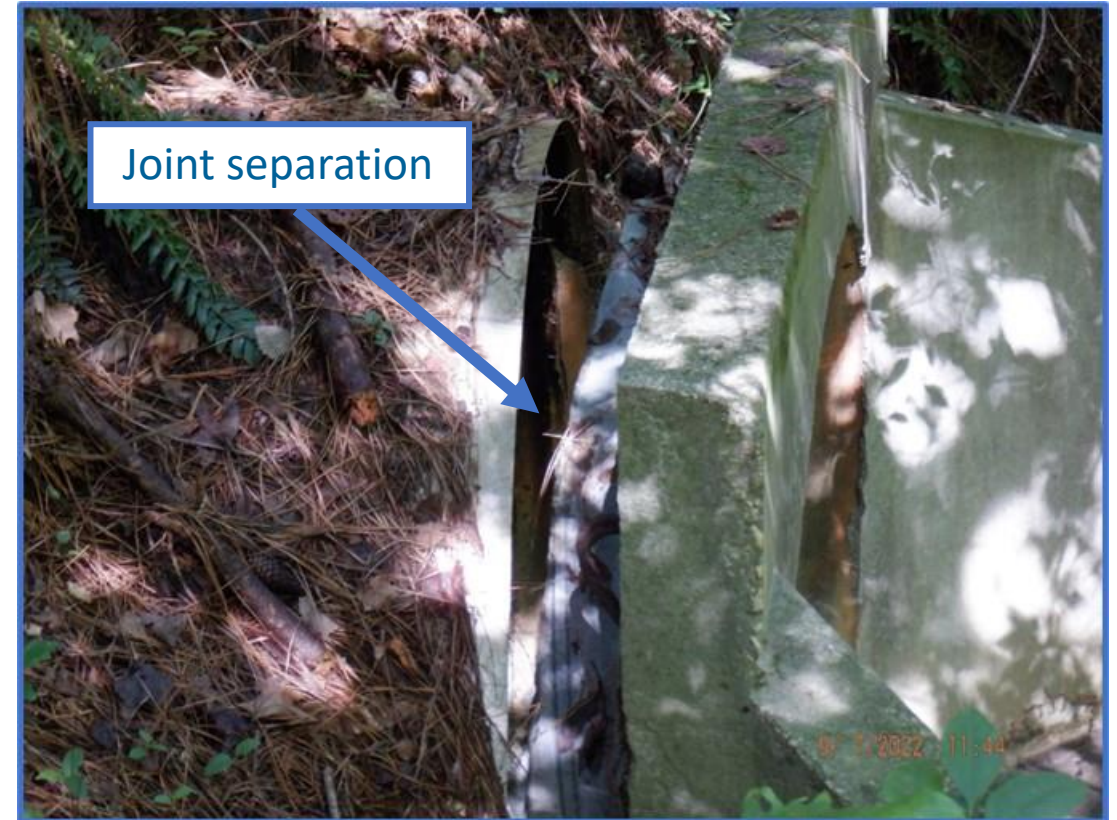
Typical Deficiencies - Structures

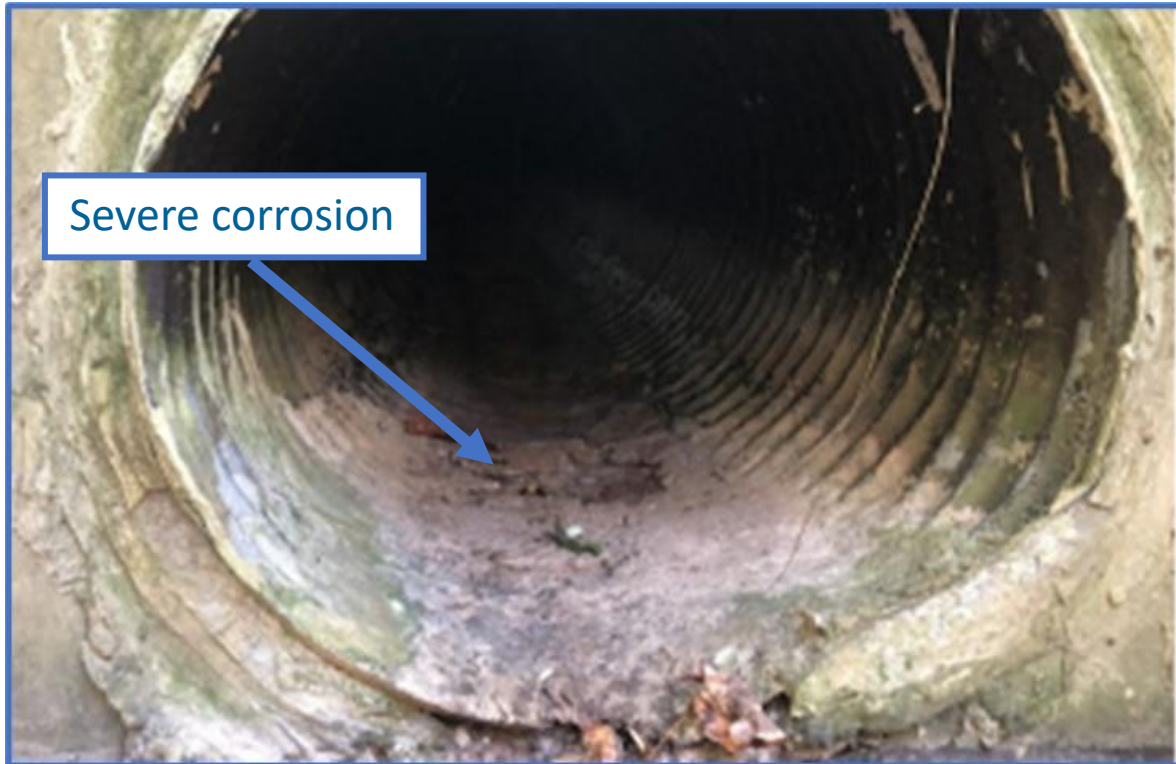
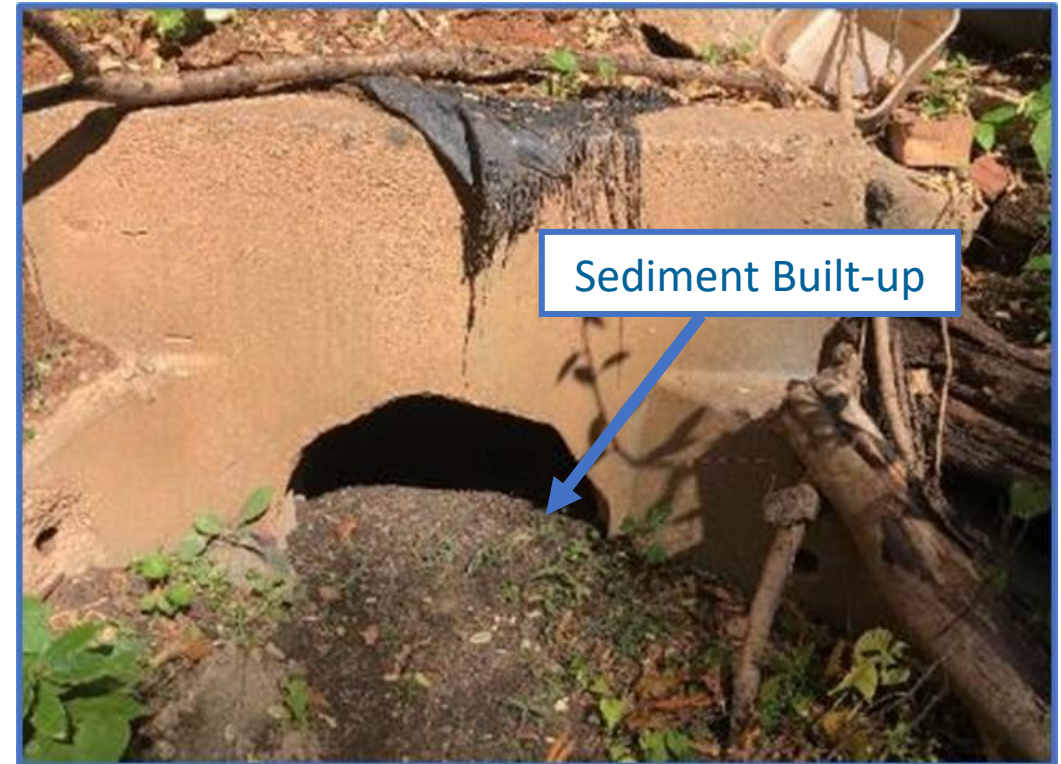
Typical Deficiencies – Pipe Aging and Loss of Capacity
